AMMRC CTR 74-26

BRITTLE MATERIALS DESIGN, HIGH TEMPERATURE GAS TURBINE

Interim Report Number 5, July 1, 1973 to December 31, 1973

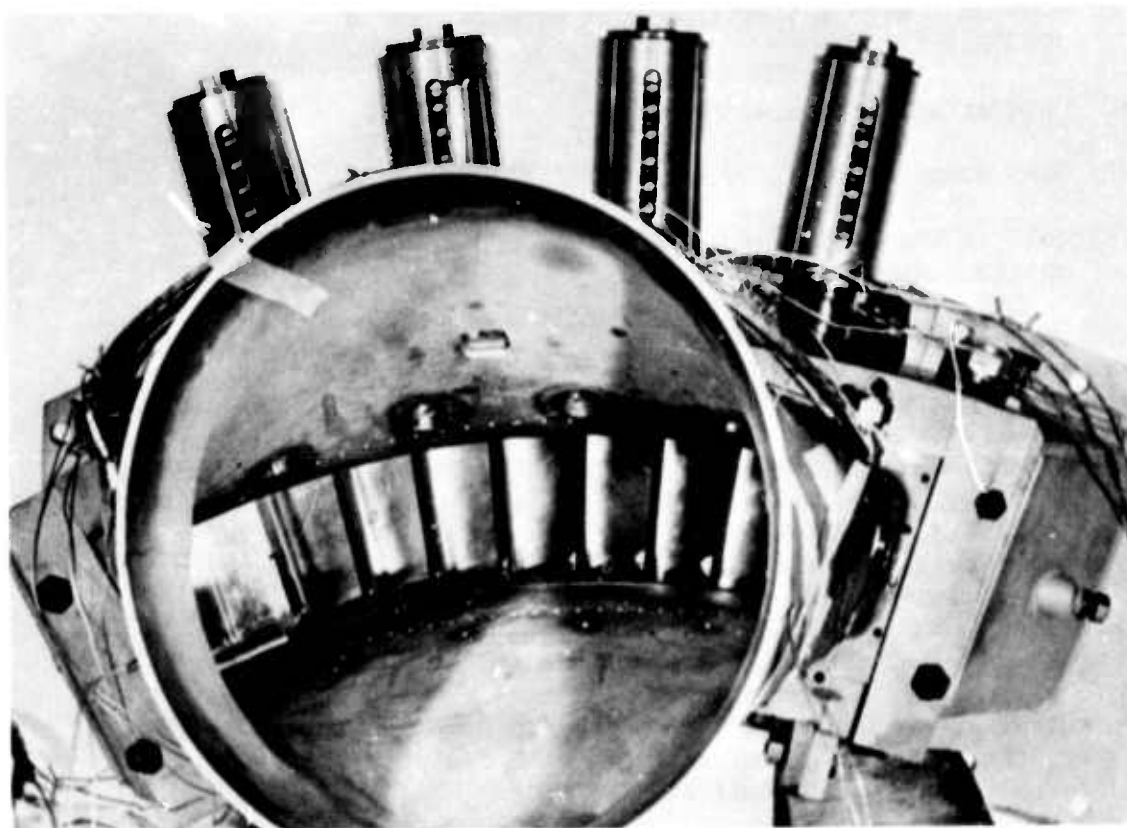
Figure 4.11 Instrumented Test Assembly for the 2200°F Static Rig Testing of Silicon Nitride Stator Vanes

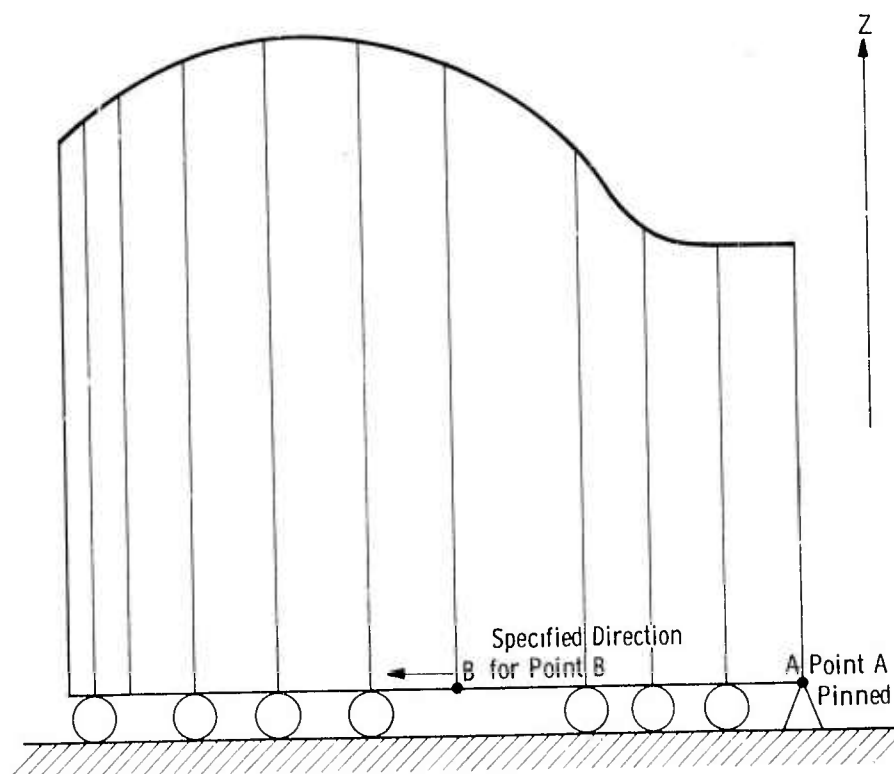
Figure 4.13 Preliminary Model for Two-Dimensional Transient Heat Transfer and Stress Analyses of Silicon Nitride Vanes under Static Rig Test Conditions at 2200°F Peak Temperature

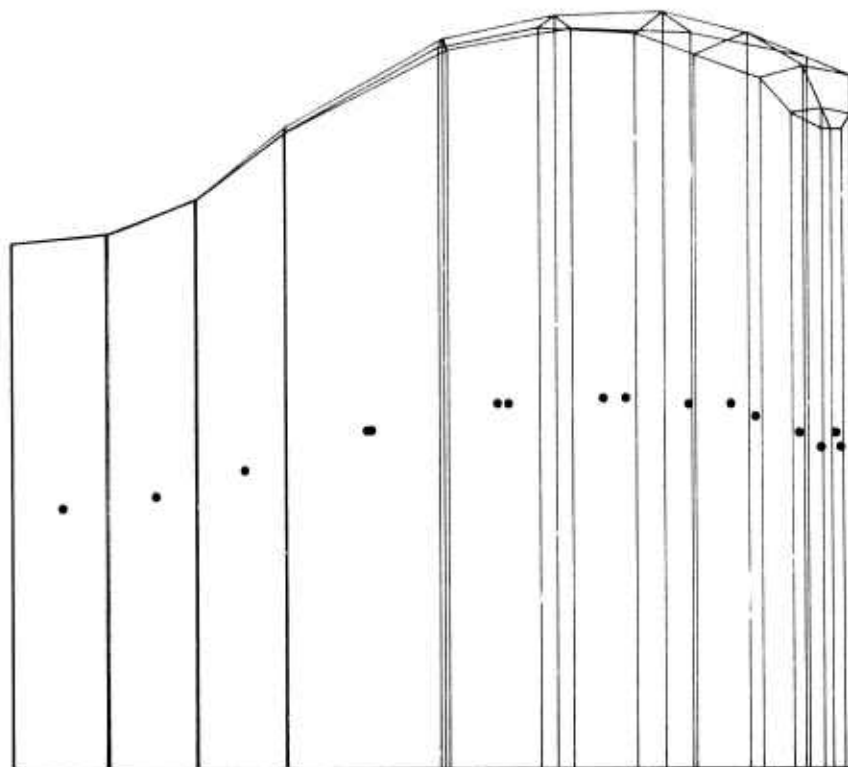
Figure 4.14 A Three-Dimensional Finite Element Plot for Heat Transfer and Stress Calculations -- Silicon Nitride Vanes

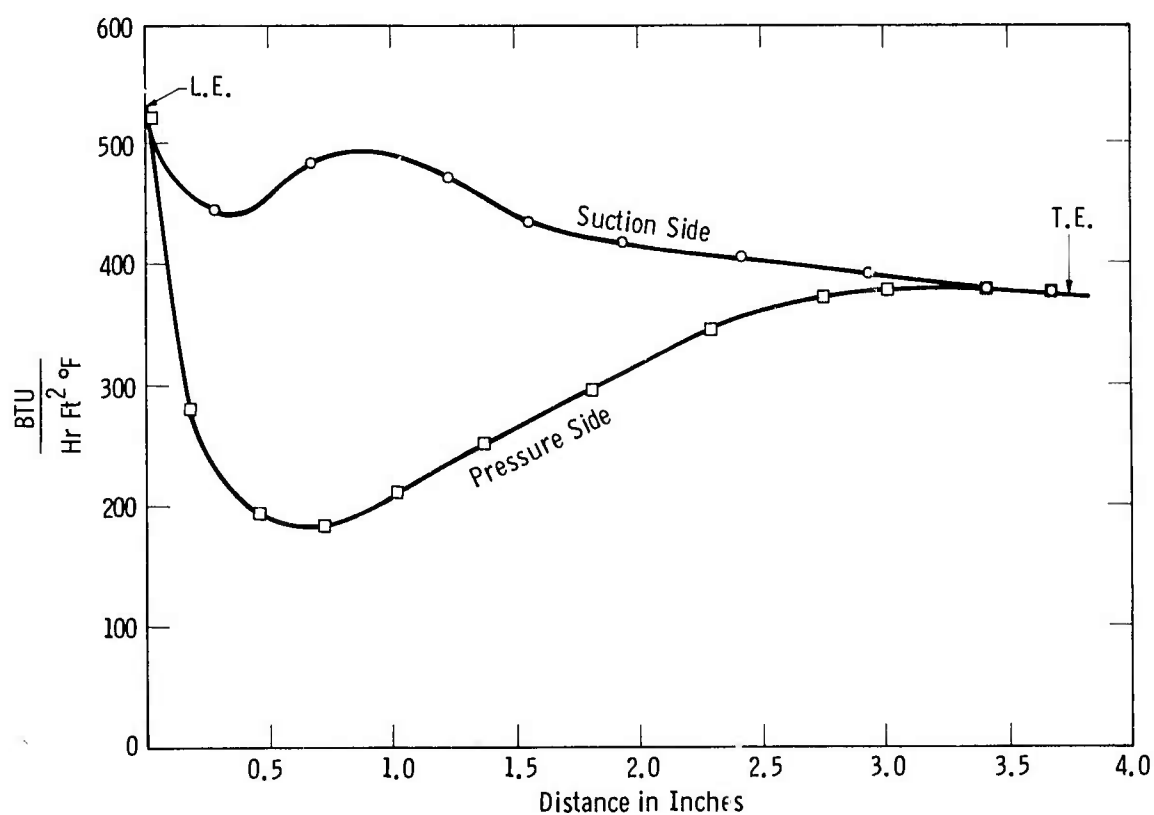
Figure 4.15 Calculated Variations in Heat Transfer Coefficients at Mid-Height Surface Locations Around a Silicon Nitride Vane

The calculated variations in heat transfer coefficient around the airfoil at mid-height is shown in Fig. 4.15. The heat transfer coefficients at the end of the airfoil were assumed to vary from $525 \text{ BTU/ft}^2\text{-hr-}^\circ\text{F}$ at the leading edge to $10 \text{ BTU/ft}^2\text{-hr-}^\circ\text{F}$ on the end buried in the end cap cavity.

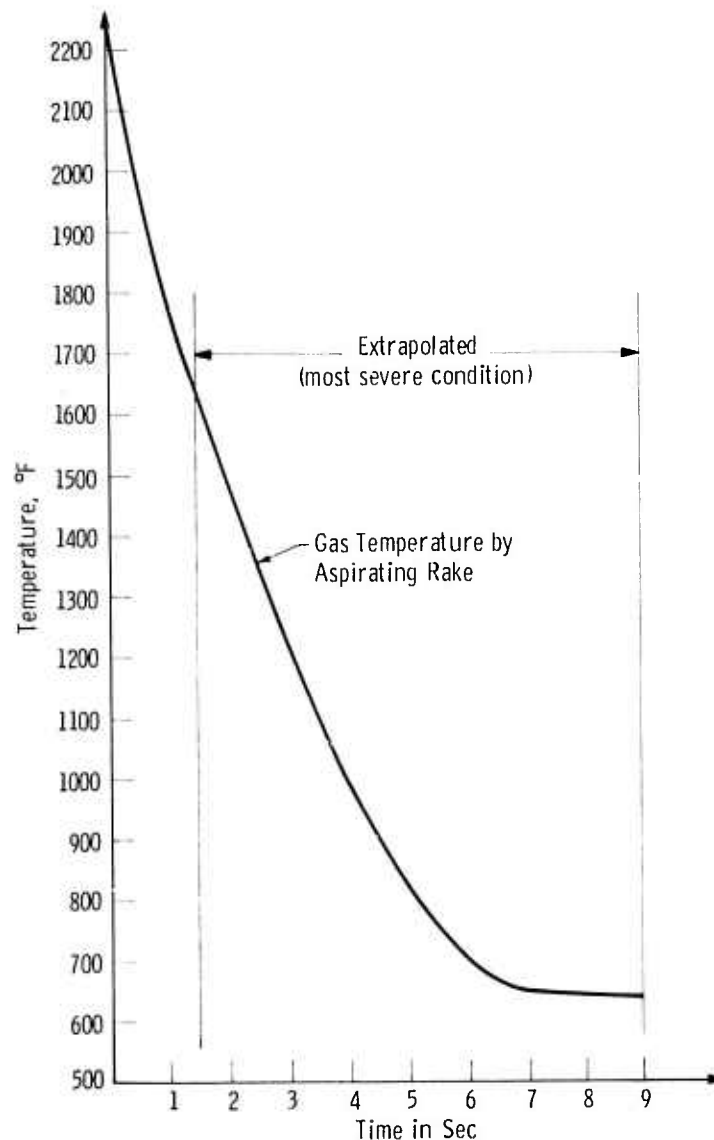
Figure 4.16 Emergency Shutdown Ramp for Ceramic Static Rig Test at 0.8 Simulation

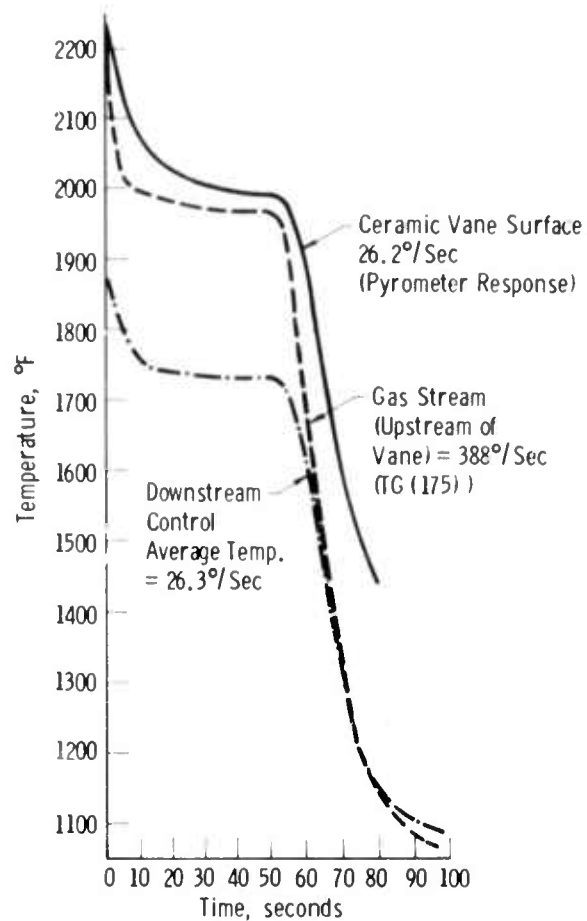
Figure 4.20 Comparison of Temperature Transients as Measured by Downstream Control Thermocouples, Upstream Gas Thermocouple Rakes, and the Radiation Pyrometer

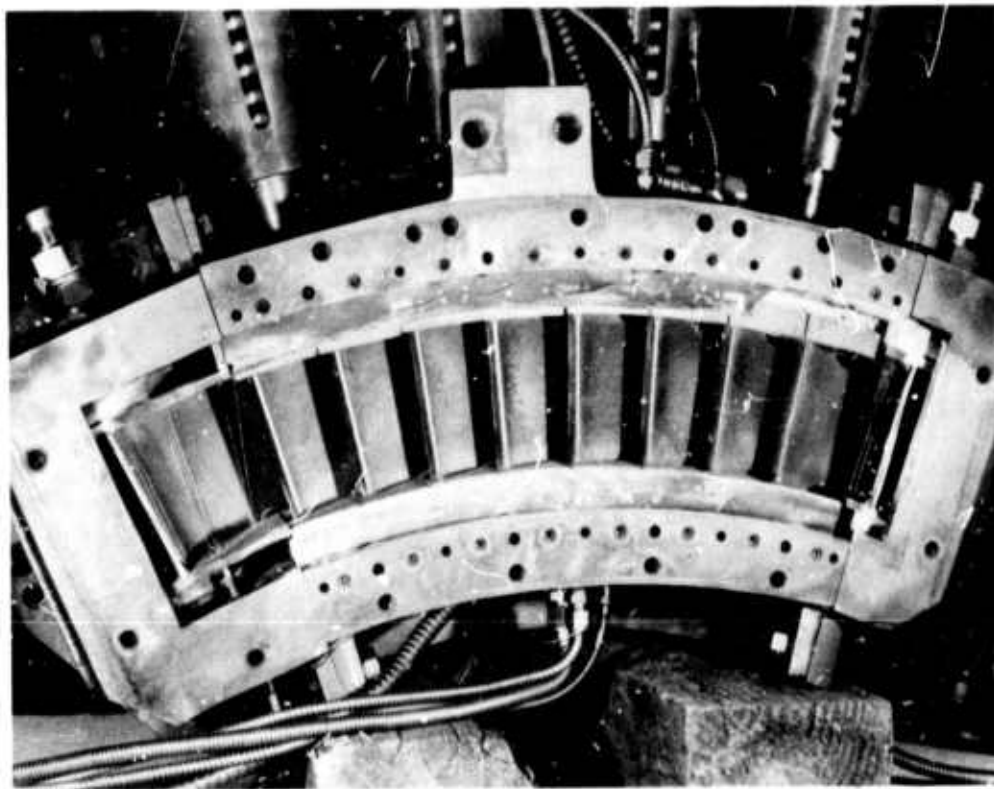
Figure 4.22 Silicon Nitride Vanes in Static Rig Test Assembly at the Completion of 2200°F Tests

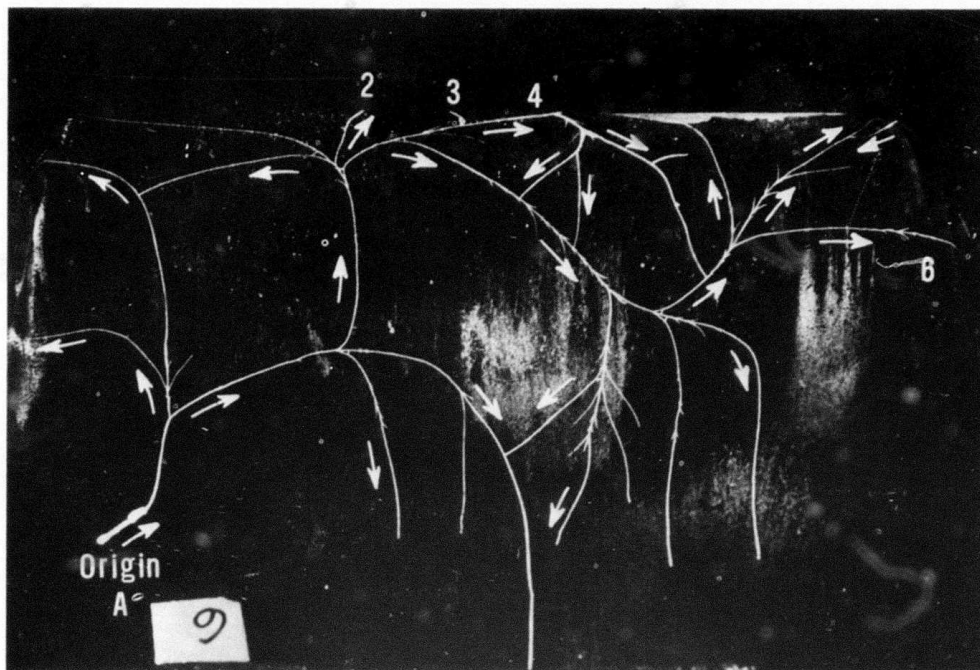
Figure 4.23 Ultraviolet Xylo Photograph of Si_3N_4 Airfoil Showing Typical Crack Patterns after 2200°F Static Rig Tests (Suction Side of Airfoil)

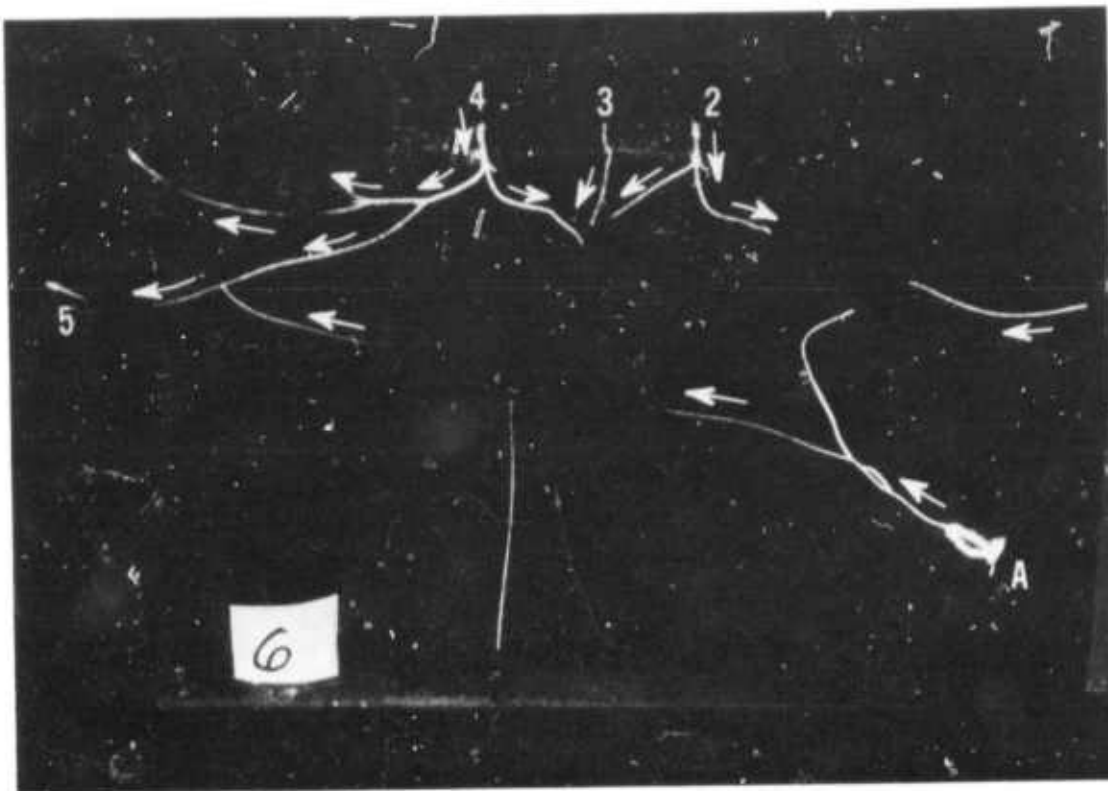
Figure 4.24 Ultraviolet Xyglo Photograph of Typical Crack Pattern Development on the Pressure Side of Si_3N_4 Airfoil after 2200°F Static Rig Tests

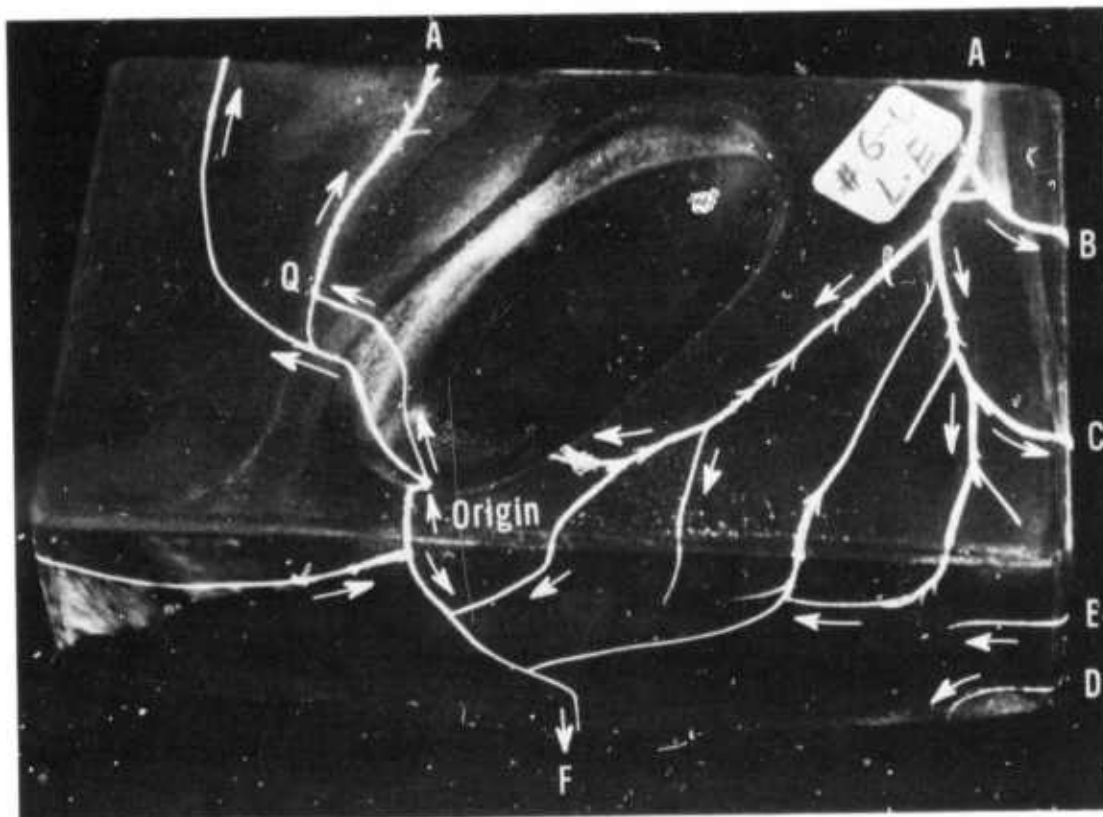
Figure 4.25 Ultraviolet Xyglo Photograph of Failure Indications in Outer End Cap 6 after 2200°F Static Rig Tests

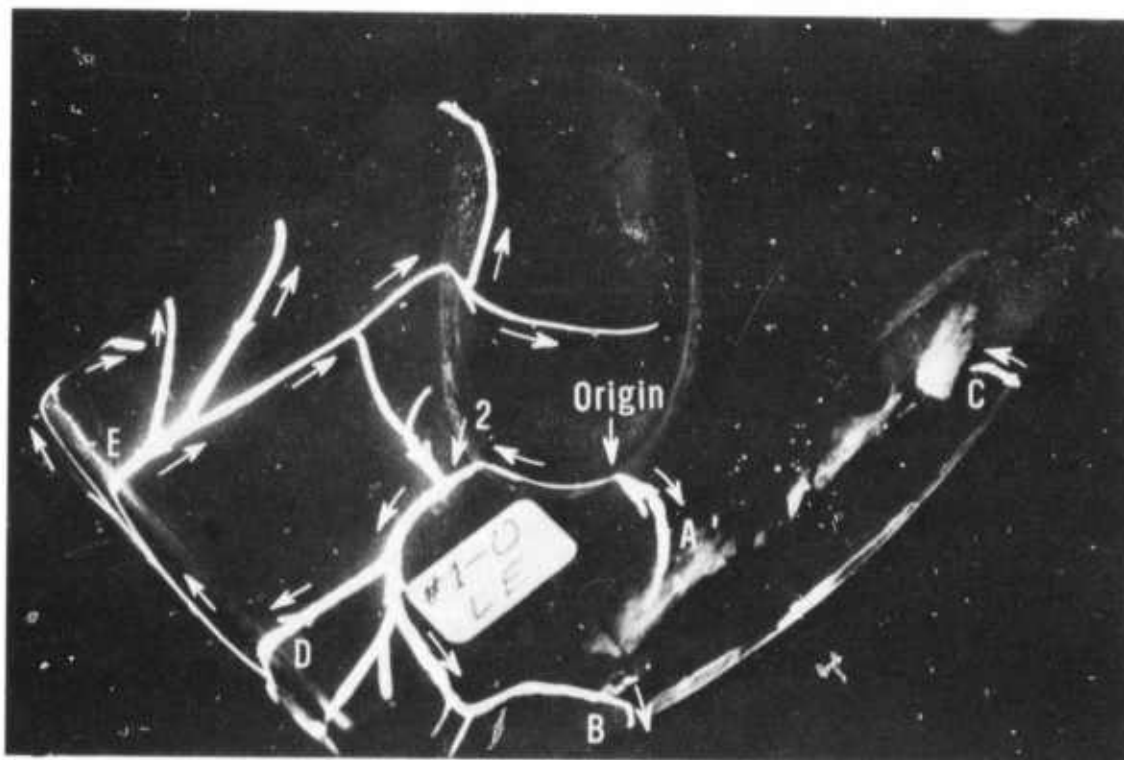
Figure 4.26 Ultraviolet Xylo Photograph of Crack Pattern Development in Outer End Cap 1 after 2200°F Static Rig Tests

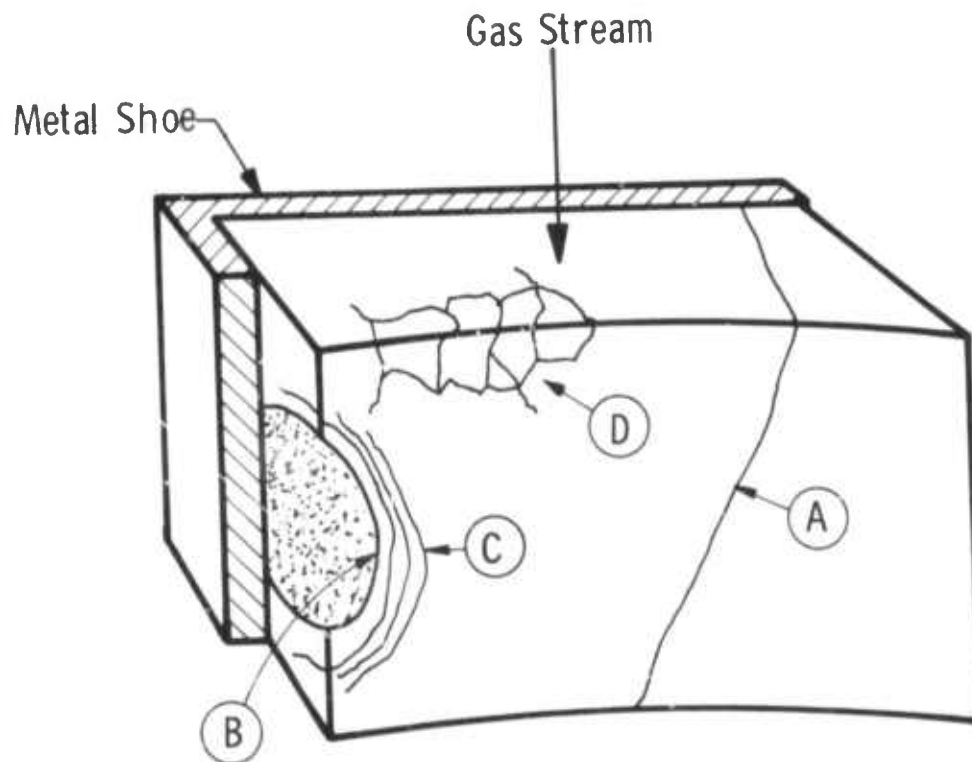
Figure 4.30 Typical Failure Indication in LAS Insulators as Seen From the End Cap-Insulator Interface

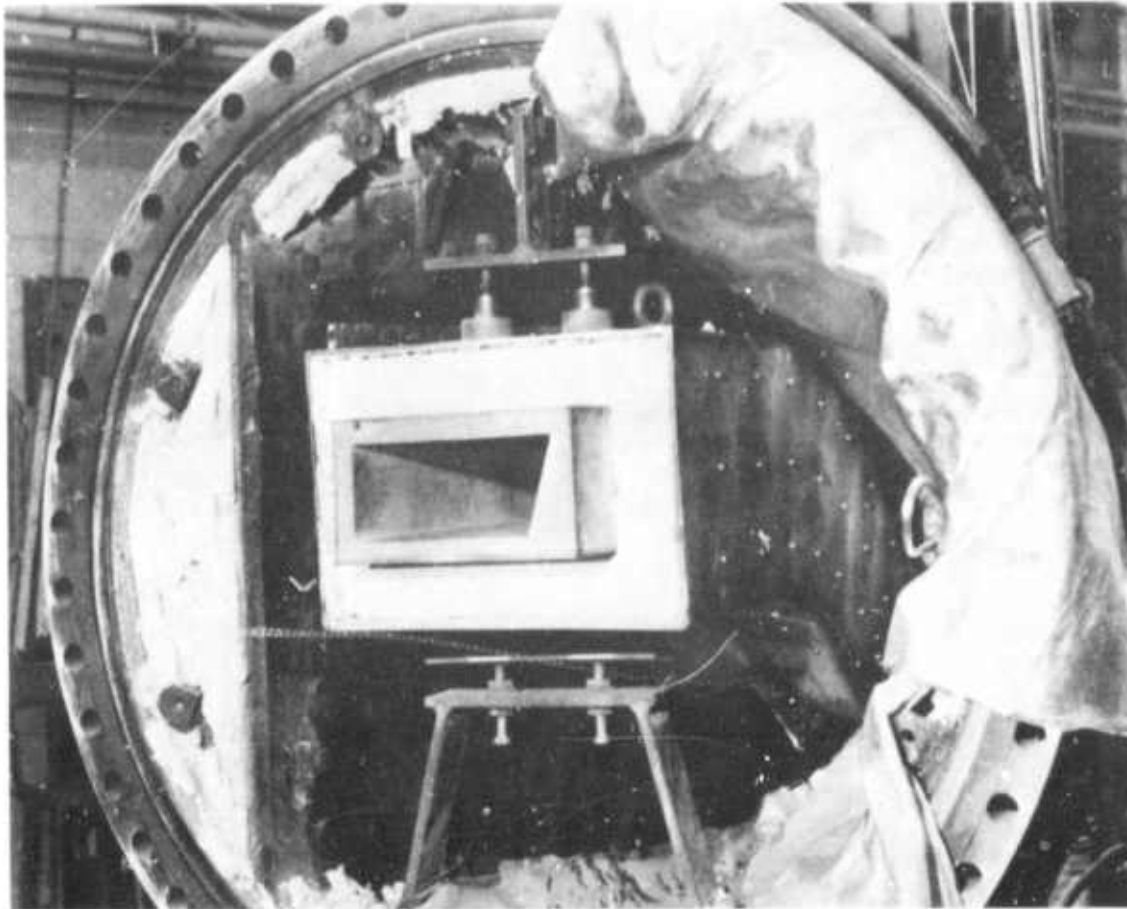
Figure 4.31 Installation of Ceramic Duct in the Static Rig for Tests
at 2500°F Peak Temperature

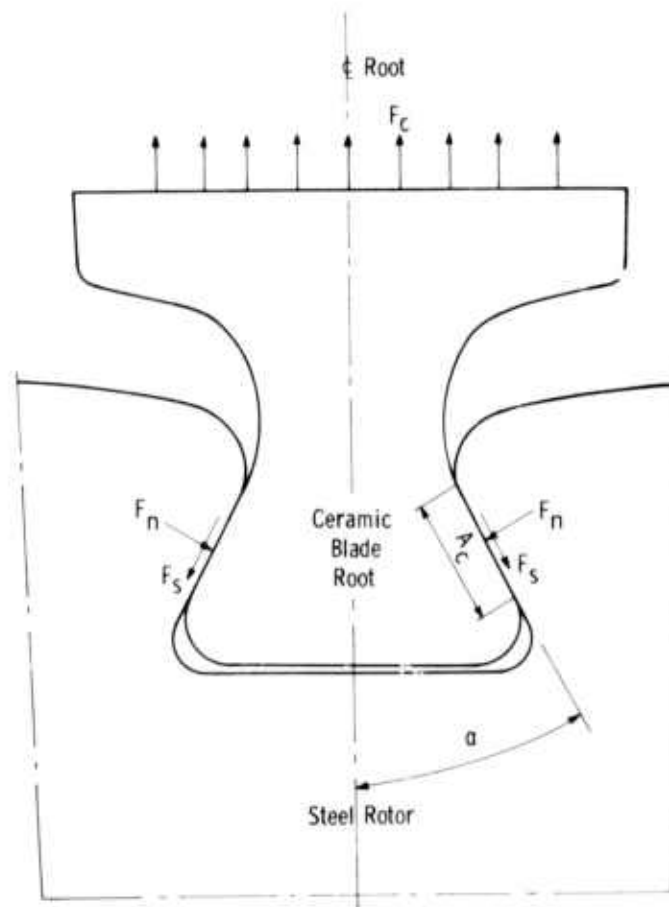
Figure 4.32 Schematic Drawing of Proposed Ceramic Blade Attachment with Metal Rotor Disc

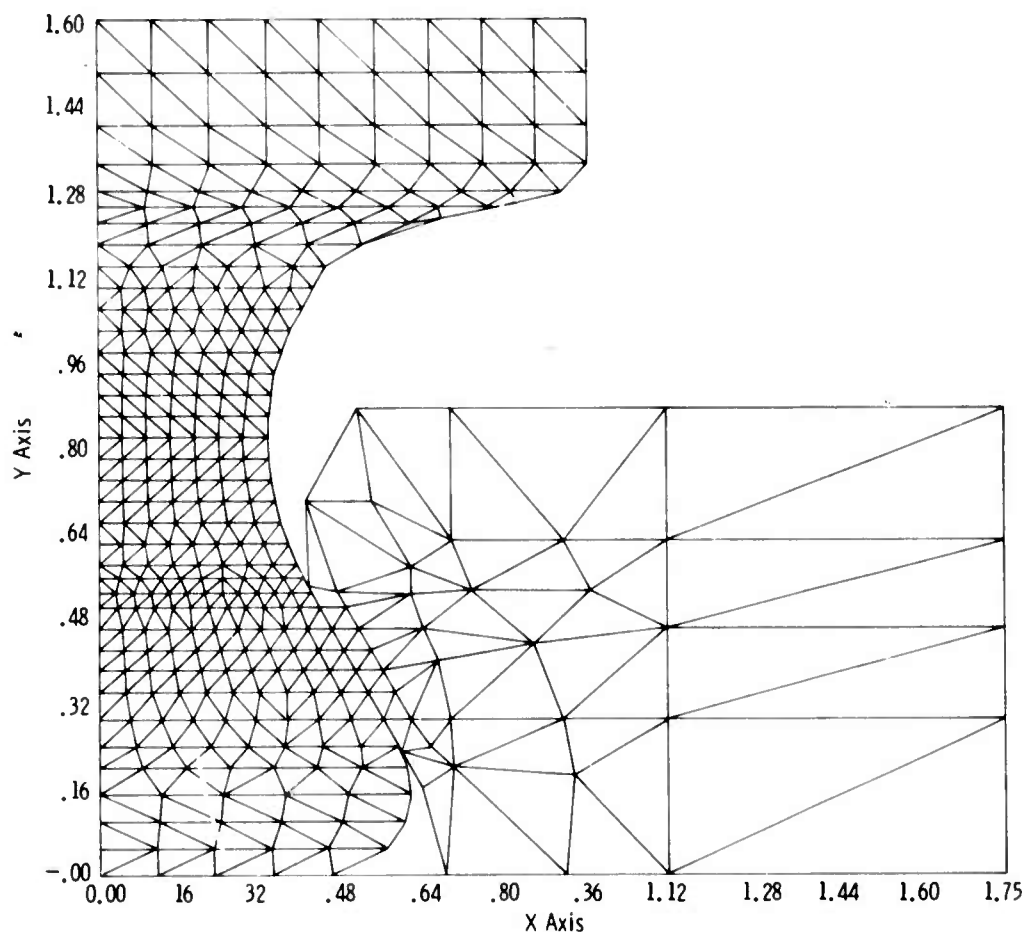
Figure 4.33 Two-Dimensional Finite Element Model of Ceramic Blade Root and Metal Rotor Disc

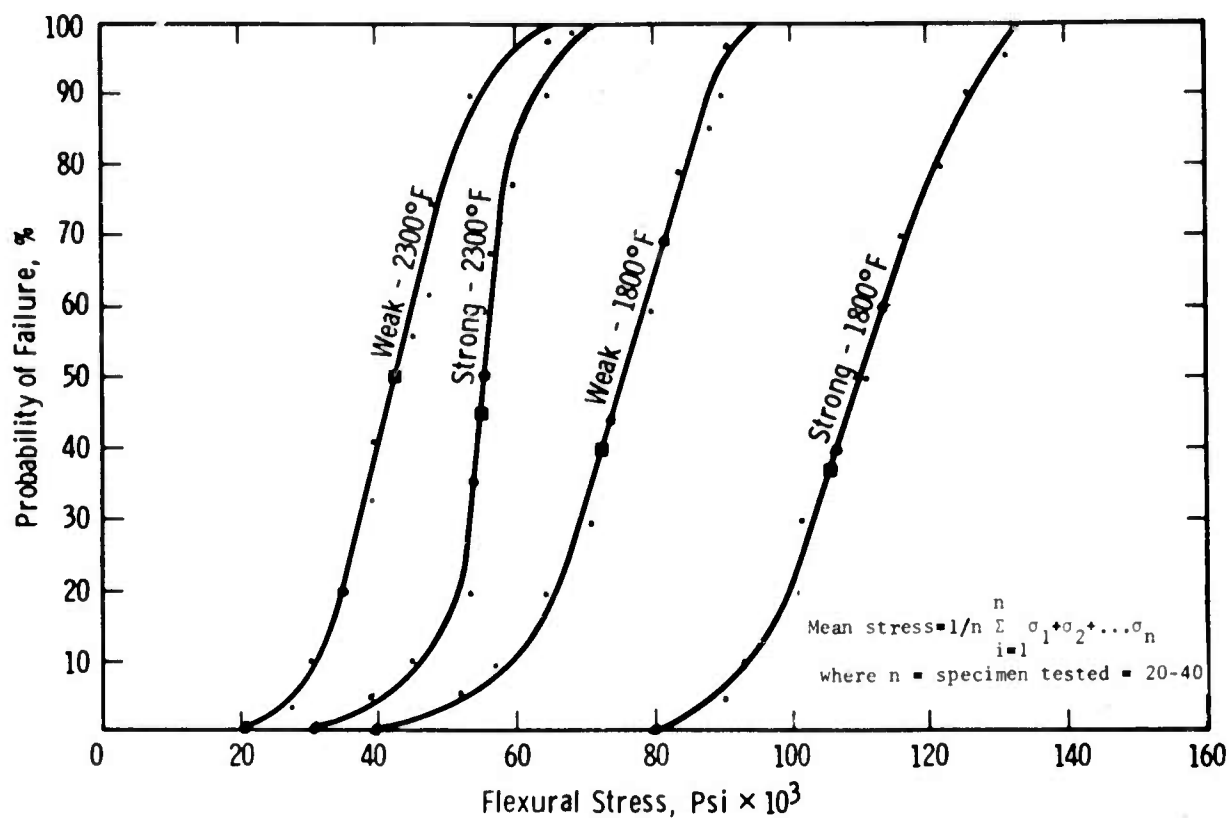
Figure 5.4 Failure Probability for Norton HS-130 Si_3N_4

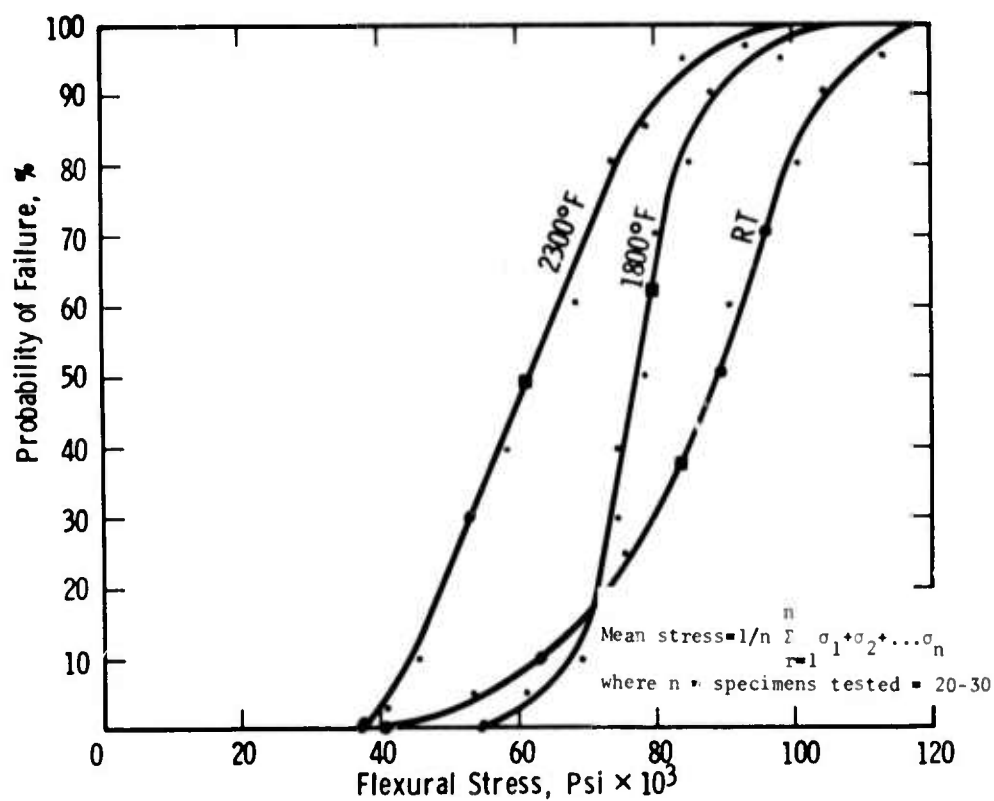
Figure 5.5 Failure Probability for Norton Hot-Pressed SiC

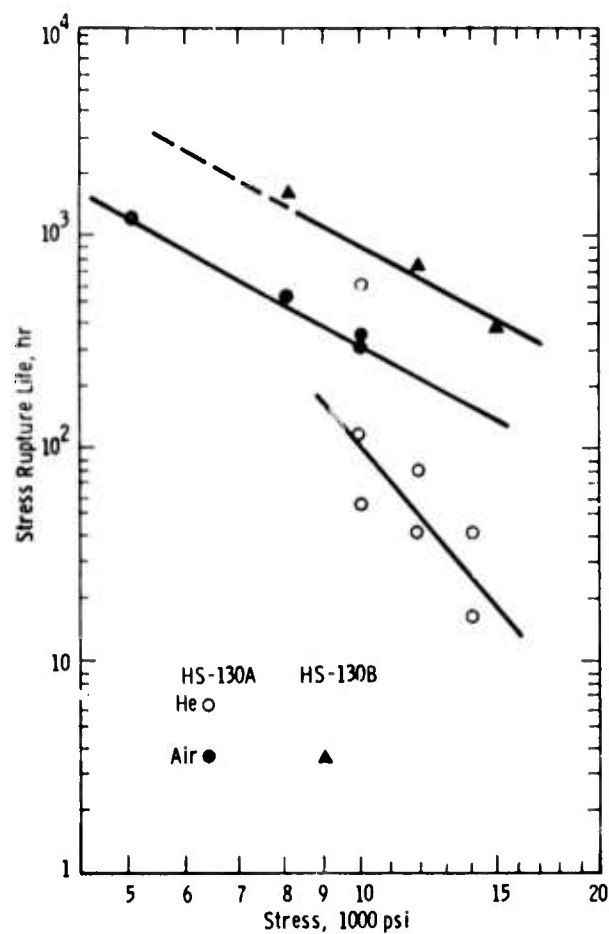
Figure 5.6 The Stress Rupture Properties of Norton HS-130 Silicon Nitride at 2300°F

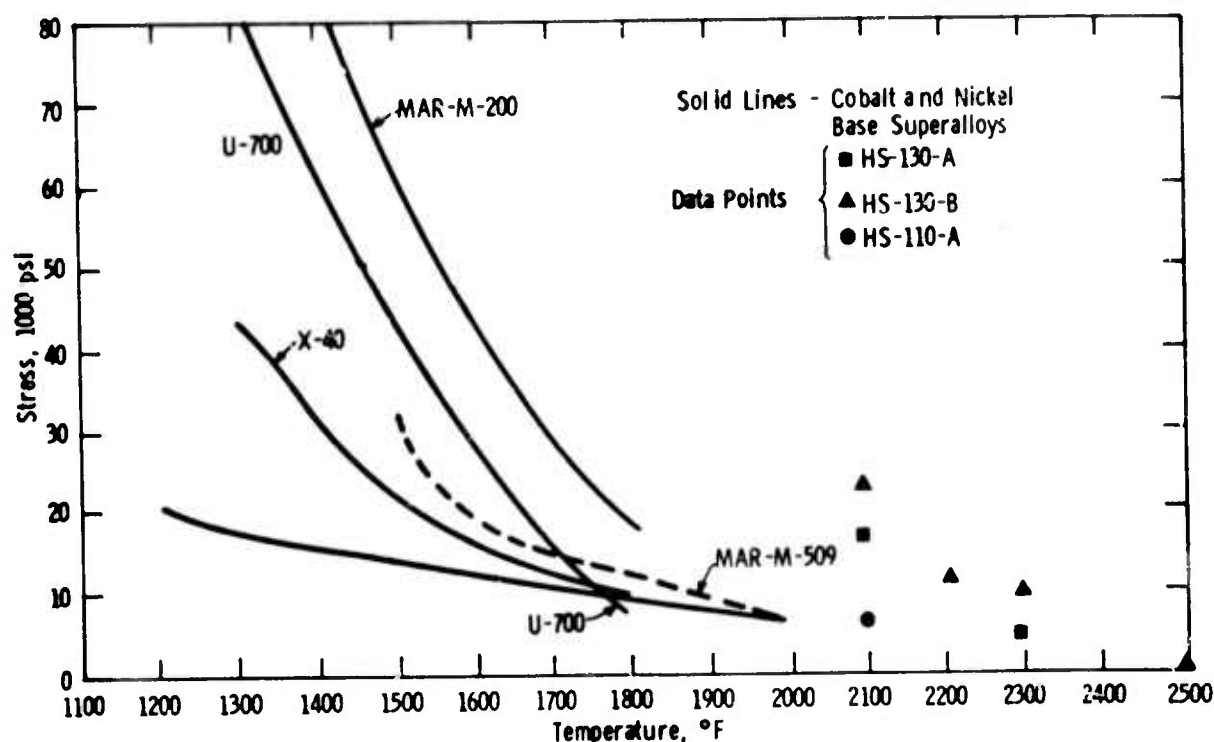
Figure 5.10 The 1000 Hour Stress Rupture Characteristics of Si_3N_4 and Selected Superalloys

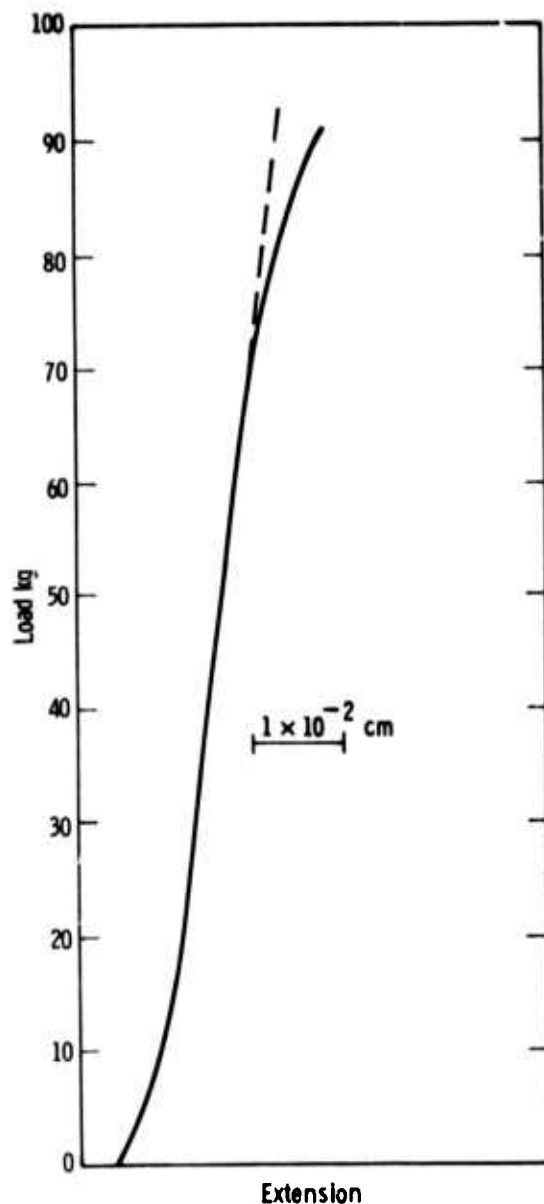
Figure 5.14 Typical Load Extension Curve for Silicon Nitride in the Weak Direction at 2350°F

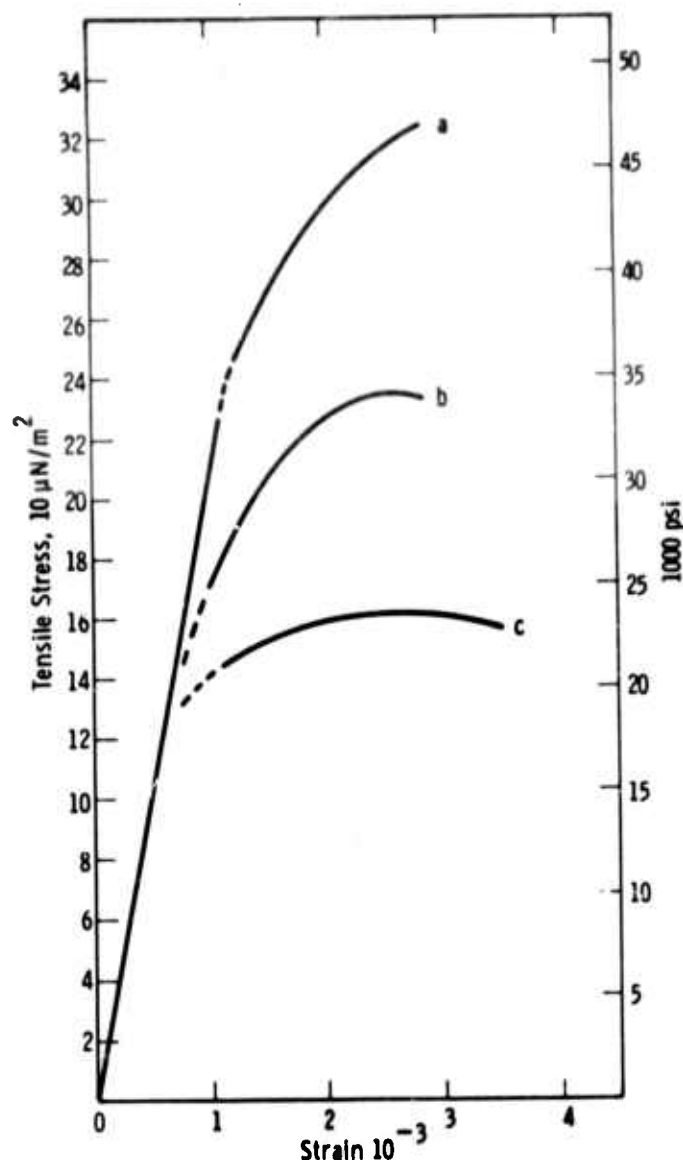
Figure 5.15 Computed Stress-Strain Curves for (a) an Elastic Solution, (b) a Plastic Solution; and (c) a Tensile Plastic-Compression Plastic Solution (Si_3N_4 Weak Direction)

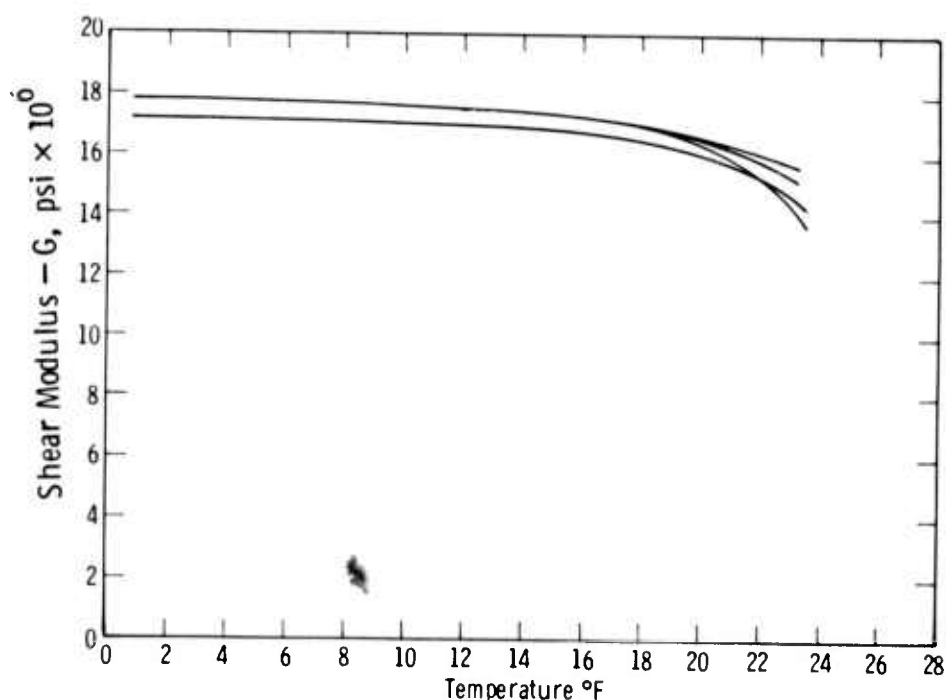
Figure 5.16 The Effect of Temperature on the Shear Modulus of Si₃N₄

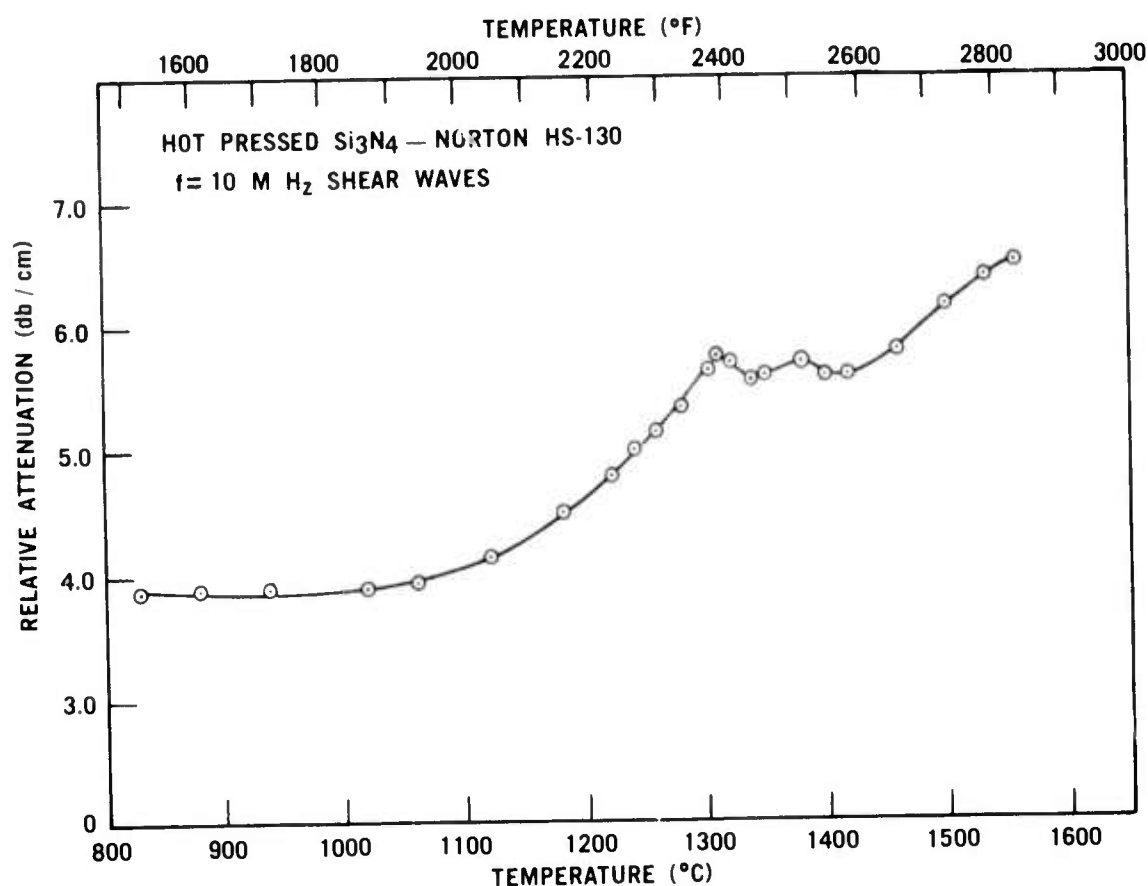
Figure 5.19 Ultrasonic Attenuation of Hot-Pressed Silicon Nitride

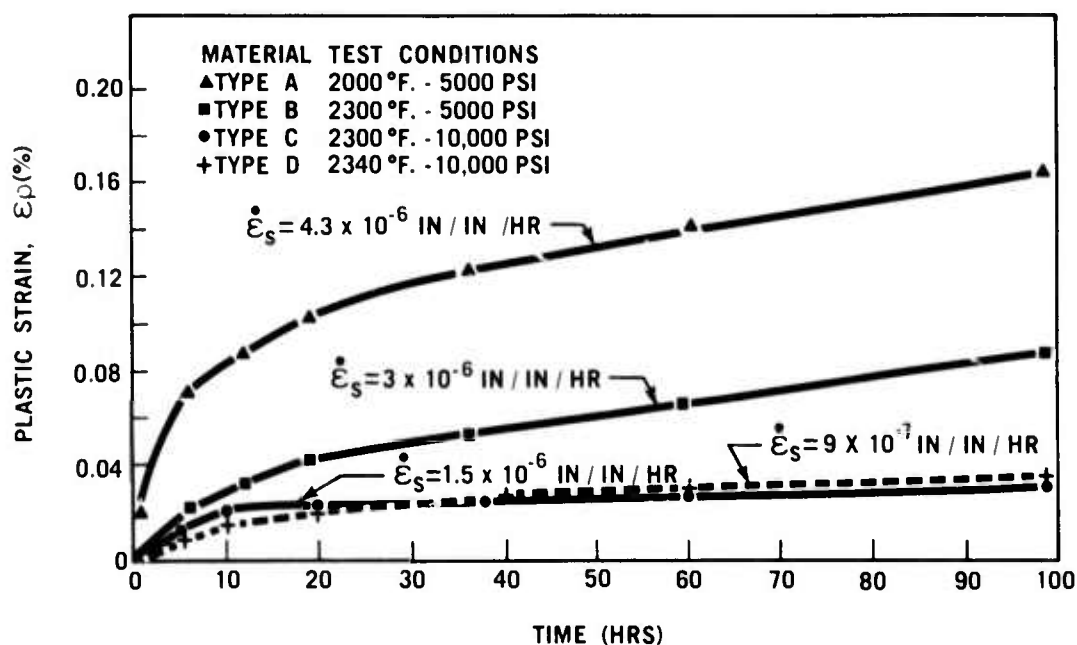
Figure 5.21 Plastic Strain vs Time For Several Types of Reaction Sintered Silicon Nitride

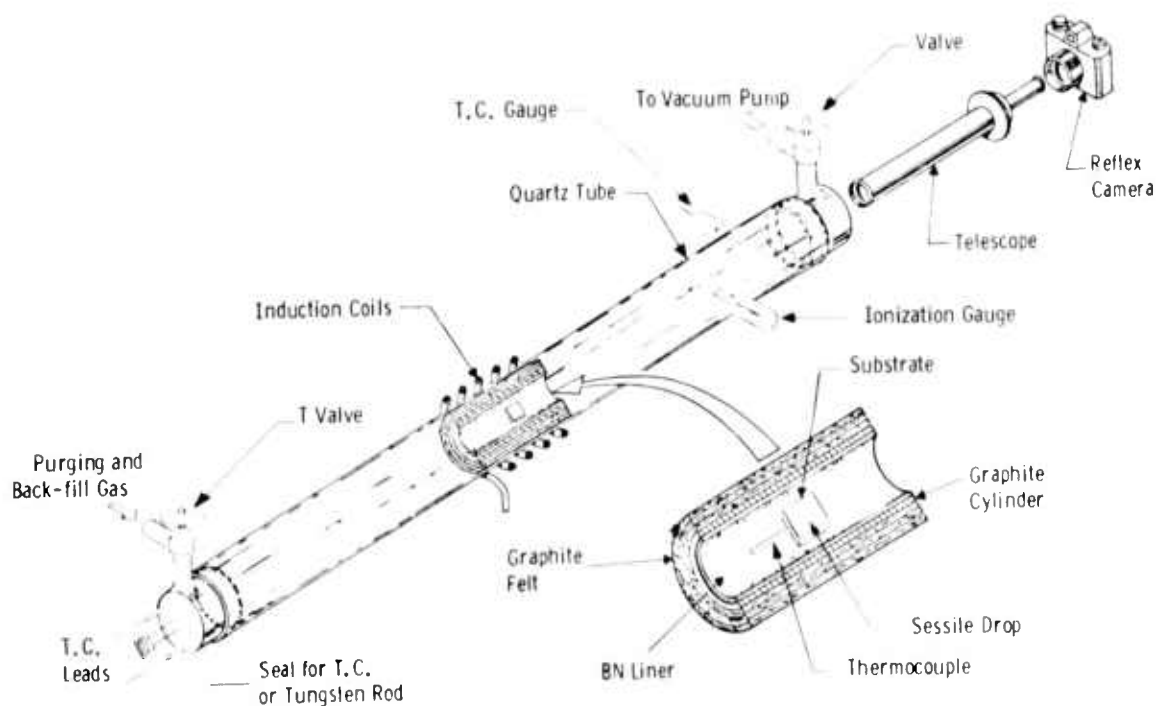
Figure 5.24 Apparatus for the Measurement of Contact Angle

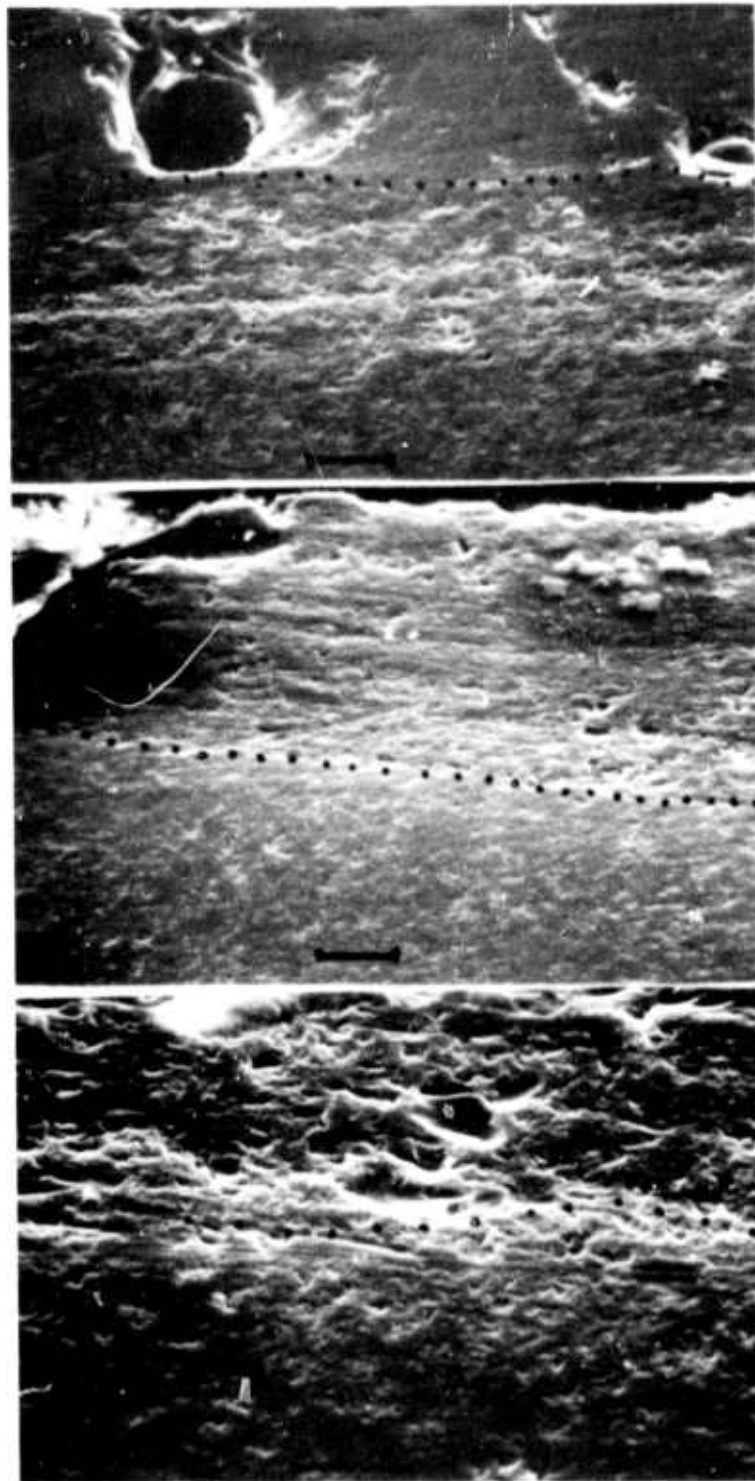
Figure 5.30 SEM Micrographs of Transverse Sections Through the Glass-Si₃N₄ Interface for:
 (a) 80 SiO₂·20 MgO
 (b) 95 SiO₂·5 MgO
 (c) 95 SiO₂·5 CaO
 (Dotted Lines Mark Original Si₃N₄ Surface, 20 μm Scale)

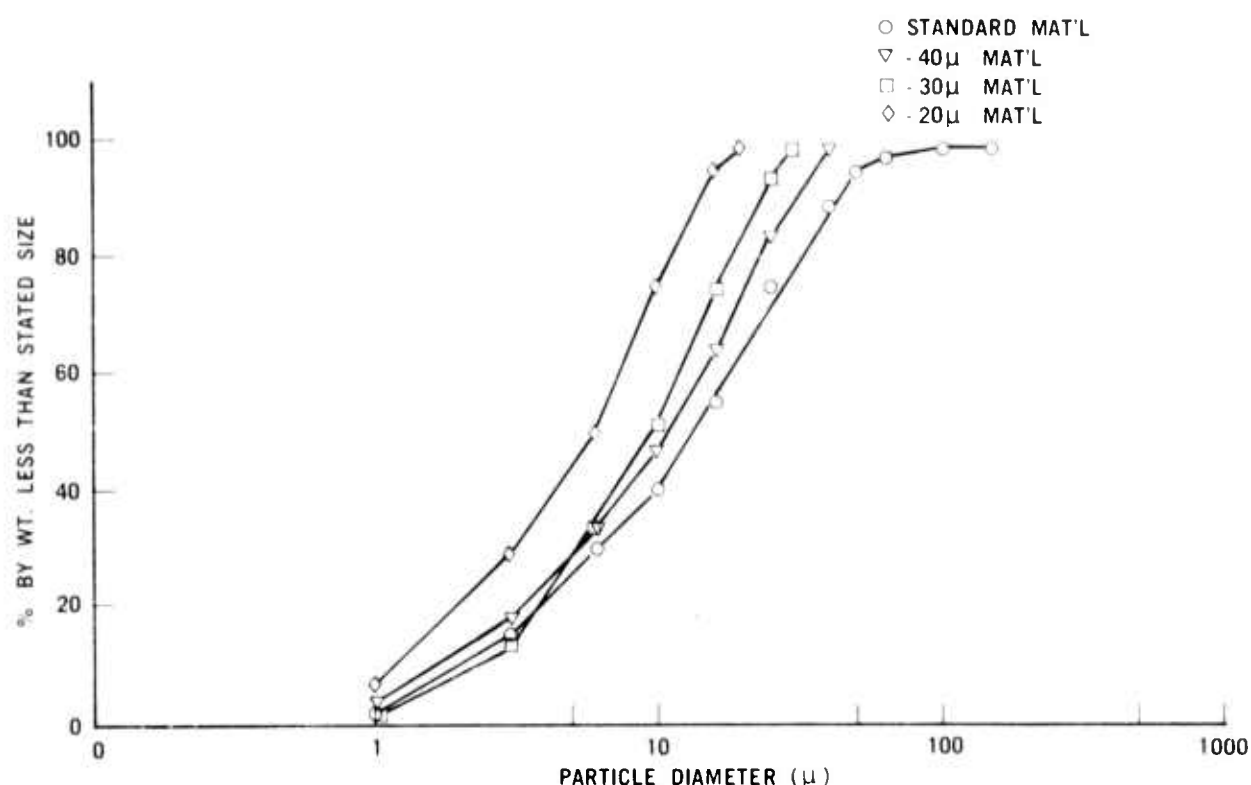
Figure 5.35 Particle Size Distribution of Silicon Metal Powders
